**Flood Control Project Maintenance
Levee Inspections**

Maintenance Issue Types Only, Levee Inspection Report By Mile - Spring 2015

Sutter Maintenance Yard Hamilton Bend

Waterway	Bank	Unit Miles	Inspection Start/End	Inspector
Unit No. 01 Feather River Hamilton Bend	Right	3.39	04/27/2015 04/27/2015	Michael Pitta

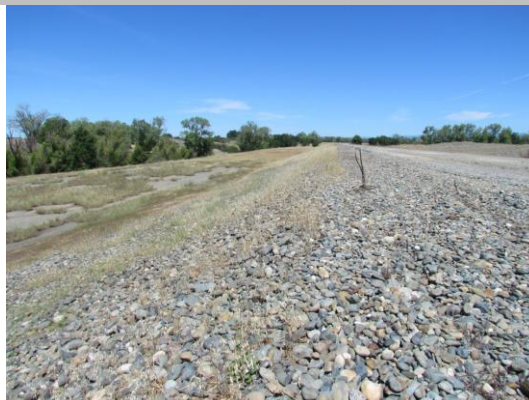
Photo 1 of 1 : SP_2015_ST0005_289_13_20150429_00013.jpg

LM Start	0.01	Rating **	A/W	Issue No.	13
LM End	1.22	Issue Type +	Ma	Location *	LS
Category	Earthen Levee			GPS Latitude/Longitude	
				Start	End
Item	Vegetation			39.439884 °	39.456794 °
				-121.641430 °	-121.639288 °
DWR ID	DWR_ST0005_01_s _ 2015_13				
Action/Comments					
Control annual grass and weeds on the levee slopes and easements.

View of the vegetation on the landside of the levee facing upstream.

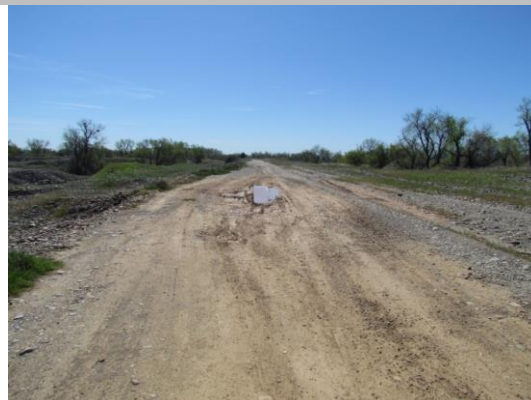
Photo 1 of 1 : SP_2015_ST0005_289_12_20150401_00004.jpg

LM Start	0.37	Rating **	M	Issue No.	12
LM End	0.37	Issue Type +	Ma	Location *	CR
Category	Earthen Levee			GPS Latitude/Longitude	
				Start	End
Item	Crown Surface / Depressions / Rutting			39.445008 °	39.445008 °
				-121.641811 °	-121.641812 °
DWR ID	DWR_ST0005_01_s _ 2014_12				
Action/Comments					
Repair depressions or ruts in the crown or slope.

This photo was taken from the levee crown facing north looking at crown surface depressions caused by vehicle traffic. Spring 2014.

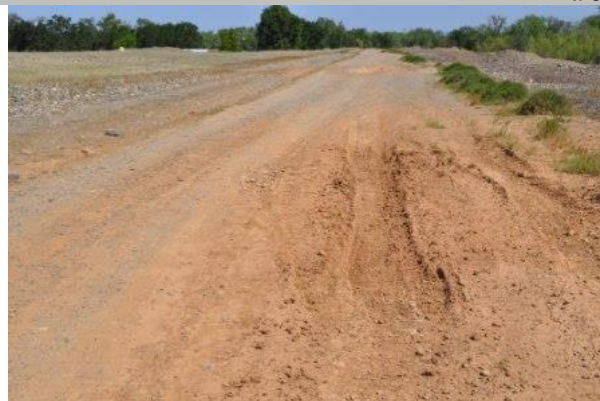
Photo 1 of 1 : SP_2015_ST0005_289_2_20150401_00001.jpg

Deep rut in crown. Repair prior to flood season.

LM Start	0.40	Rating **	M	Issue No.	2
LM End	0.40	Issue Type +	Ma	Location *	CR
Category	Earthen Levee			GPS Latitude/Longitude	
				Start	End
Item	Crown Surface / Depressions / Rutting			39.445420 °	39.445430 °
				-121.641809 °	-121.641802 °
DWR ID	DWR_ST0005_01_s _ 2015_2				
Action/Comments					
Add appropriate material and re-grade the levee to bring the crown above the design elevation.

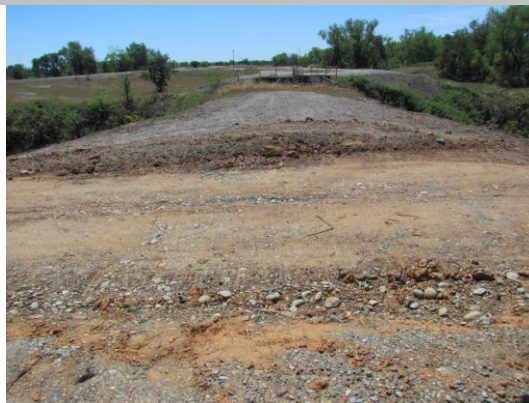
Photo 1 of 2 : SP_2015_ST0005_289_18_20150429_00011.jpg

LM Start	1.08	Rating **	U	Issue No.	18
LM End	1.08	Issue Type +	Ma	Location *	CR
Category	Earthen Levee			GPS Latitude/Longitude	
				Start	End
Item	Crown Surface / Depressions / Rutting			39.454935 °	39.454935 °
				-121.640097 °	-121.640097 °
DWR ID	DWR_ST0005_01_s _ 2015_18				
Action/Comments					
Repair depressions or ruts in the crown or slope.

View of the depression on the crown facing downstream.

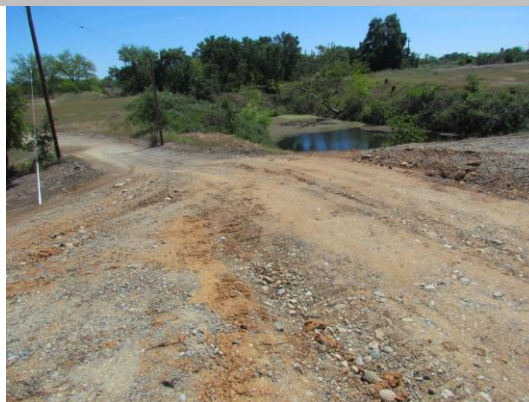
Photo 2 of 2 : SP_2015_ST0005_289_18_20150429_00012.jpg

LM Start	1.08	Rating **	U	Issue No.	18 (cont)
LM End	1.08	Issue Type +	Ma	Location *	CR

View of the depression on the crown facing the waterside of the levee.

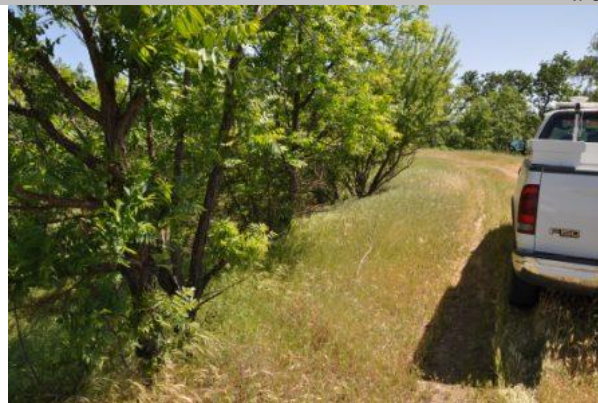
Photo 1 of 1 : SP_2015_ST0005_289_4_20150401_00002.jpg

L/S trees.

LM Start	1.48	Rating **	M	Issue No.	4
LM End	3.26	Issue Type +	Ma	Location *	LS
Category	Earthen Levee			GPS Latitude/Longitude	
				Start	End
Item	Trim / Thin Trees			39.458060 °	39.470433 °
				-121.636332 °	-121.609200 °
DWR ID	DWR_ST0005_01_s_2013_4				
Action/Comments					
Trim and thin trees to allow visibility of the ground and room to flood fight.

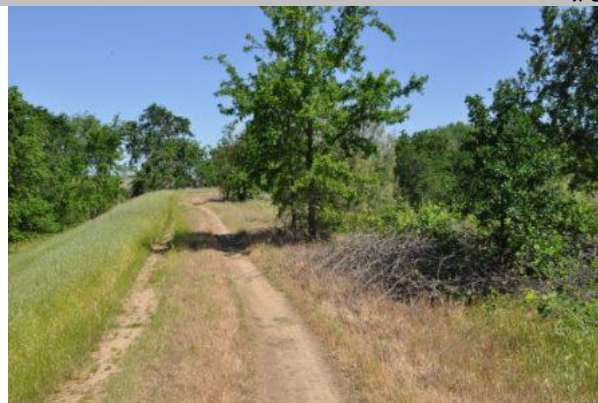
Photo 1 of 1 : SP_2015_ST0005_289_5_20150401_00003.jpg

W/S trees.

LM Start	1.51	Rating **	M	Issue No.	5
LM End	1.69	Issue Type +	Ma	Location *	WS
Category	Earthen Levee			GPS Latitude/Longitude	
				Start	End
Item	Trim / Thin Trees			39.458255 °	39.459451 °
				-121.635808 °	-121.633670 °
DWR ID	DWR_ST0005_01_s _ 2013_5				
Action/Comments					
Trim and thin trees to allow visibility of the ground and room to flood fight.
